WHEN FAÇADES KILL

A problem of extreme flammability

Terri Meyer Boake / University of Waterloo

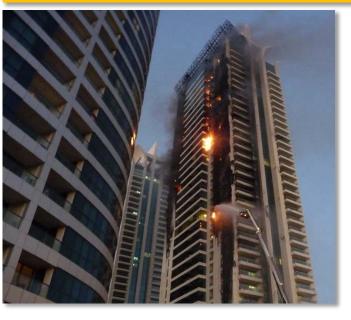
Tamweel Tower, Dubai | February 12, 2012

- 34 storey tower, 160 apartments
- Residential, operable windows, balconies
- No deaths or injuries
- Fire started on the outside of the building
- Assumed a cigarette ignited some trash on a balcony and the fire swept up the exterior
- Clad in non fire rated aluminum panels with thermoplastic core
- Residents still not able to move back into the building until late 2017
- Seen as a test case in the UAE for fire related insurance claims and repairs
- In addition to replacing the cladding they will also be raising the height of the balconies

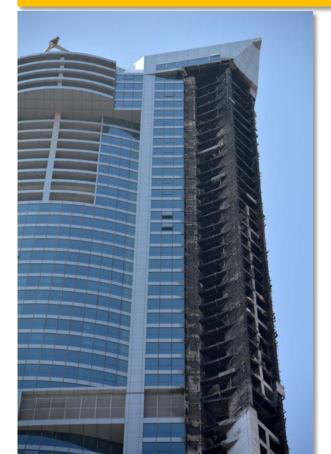
The Torch, Dubai | February 21, 2015, August 4, 2016

- 86 storey tower
- Residential, operable windows, balconies
- 4 people with minor injuries
- Fire started on the outside of the building both times
- Clad in non fire rated aluminum panels with thermoplastic core
- Fire #1: Fire alarms did not sound, people notified by occupants of an adjacent tower
- Fire #2: Alarms did sound
- Repairs to the building have yet to be completed

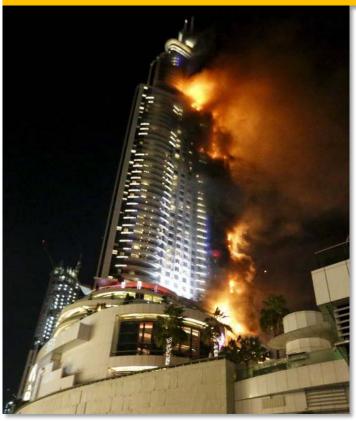
The Address, Dubai | December 31, 2015

- 63 storey tower
- Residential/hotel, operable windows, balconies
- Minor injuries
- Fire started on the outside of the building from an electrical fault from a wire for exterior lighting, located on a ledge between the 14th and 15th floors
- Clad in non fire rated Alubond aluminum panels with low density polyethylene core
- Fire alarms did not sound and sprinklers did not go off
- Emaar to receive Dh1.22 billion insurance claim
- Hotel set to reopen late 2017 (unsure if it has)

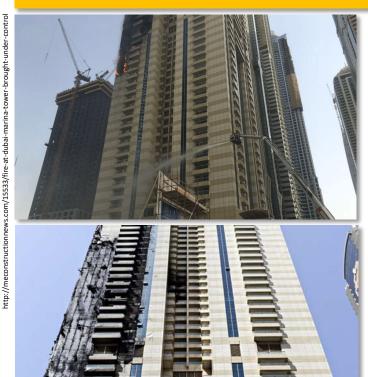
Sulafa Tower, Dubai | July 20, 2016

- 75 storey tower
- Residential, operable windows, balconies
- No injuries
- Fire started on the outside of the building from a discarded cigarette butt on the 61st floor
- Clad in non fire rated aluminum panels with low density polyethylene core
- Fire alarms did not sound and sprinklers did not go off
- 3 hours to extinguish
- 15 floors damaged
- Flames fanned by high winds

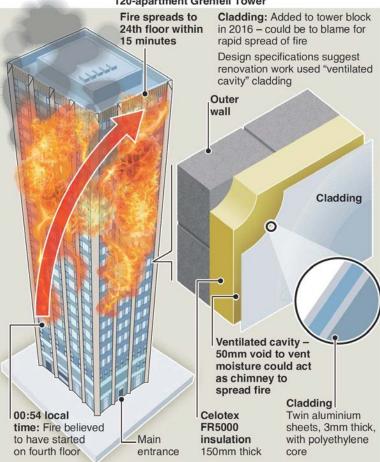
Grenfell Tower

"The cladding had a metal outer coating and an expanded foam interior. This polyethylene - or plastic - core is less fireproof than other alternatives.

However, even this type of cladding - when properly fitted and with its polyethylene insulation **expertly encapsulated** - should resist fire, the Fire Protection Association (FPA), the UK's national fire safety organisation, said." http://www.bbc.com/news/uk-40301289

The additional cavity insulation and air space make this fire very different from the UAE fires which did not use the product in this manner.

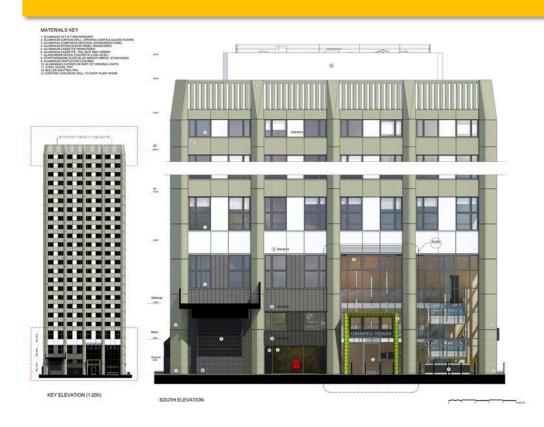
Grenfell Tower

- In a statement on its website, Omnis Exteriors said panels such as Reynobond PE should only be used with "a non-combustible insulation material such as mineral fibre" if they are to be installed on high-rise buildings.
- The fire resistant panel was dropped due to cost reasons
- Massive failures in communication
- Massive investigation underway, changes coming to the British codes.

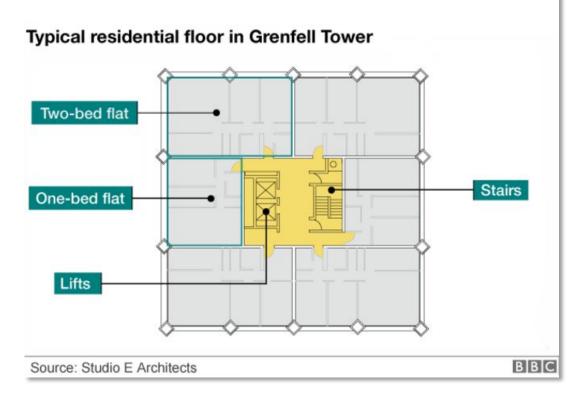
Grenfell physical issues

- Only one exit stair for 300+ people
- No sprinkler system

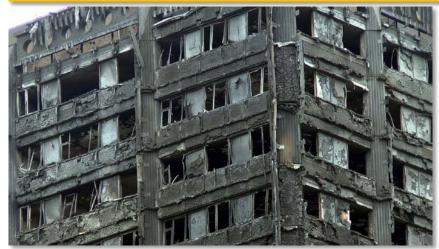
- The softening of the aluminum combined with the melting of the LDPE insulation led to the panels falling off of the building.
- Fire resistance tests for the panels assume that the panels are sealed so that the edge condition does not expose the interior LDPE core

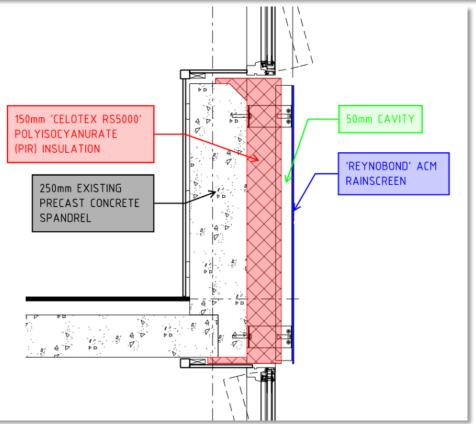
Spandrel panel failure in residential buildings

- Traditional precast concrete spandrel panel was non combustible so the separation of operable windows not a great problem for fire spread
- With a flaming exterior the spandrel panel provided no separation between the operable windows
- This would be a problem on low rise as well as high rise residential buildings.

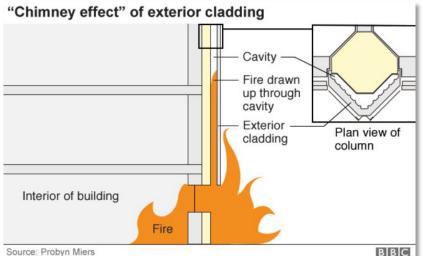
The odd shape of the Grenfell Tower columns meant that there was an airspace in front of and behind the Polyiso insulation layer, likely exacerbating the chimney effect.

- A rainscreen façade is a well established practice in Canada, and the need for firestopping to break the continuity of the channel is well known
- This applies to all types of façade cladding materials
- The vertical shafts created by the column covering in Grenfell led to the accelerated spread of the fire
- Essential to properly detail façades with cavity (rather than eliminate the cavity) as it is essential for air pressure equalization to prevent rain penetration
- Also block corners so fire or water is not pushed to adjacent façade cavities
- Cavity insulation should be of a non combustible type or if flammable, properly encapsulated
- Was not an issue in the UAE fires as no cavity there
- More education in detailing is needed

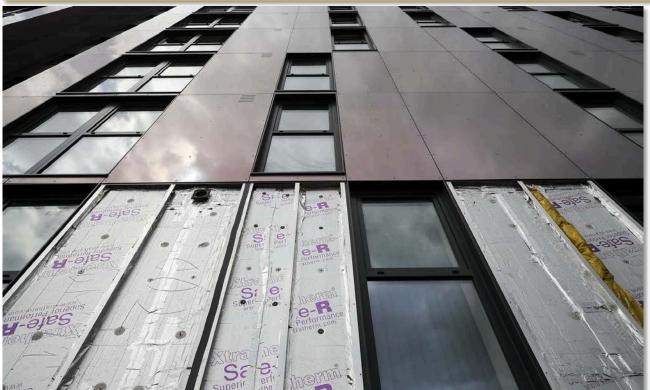
Massive testing in the UK post Grenfell

- One of the issues with the current "witch hunt" that is underway in the UK is that it lacks rigor and transparency.
- Tests are being conducted on the façade material, many failing, but there is no rigor in examine the cavity, air space and insulation behind – which exacerbated the Grenfell fire.
