# Embrace Your Braces!

**Terri Meyer Boake<sup>1</sup>**

The notion of adaptive reuse can be applied to creating resilience in structures designed to resist seismic events. Many of the issues associated with the difficulties encountered in repairing structures that have been damaged as the result of earthquakes lies as much in the hidden nature of the damage as it does in the repair and remediation of the structures. The structures are not resilient enough to resist the seismic event and are not designed to be repaired. This has been clearly evidenced in the February 22, 2011 earthquake in Christchurch, New Zealand which measured 6.3 on the Richter Scale. Much of the Central Business District of Christchurch is in the process of being systematically demolished as a result of the inability to repair the extensive structural damage.

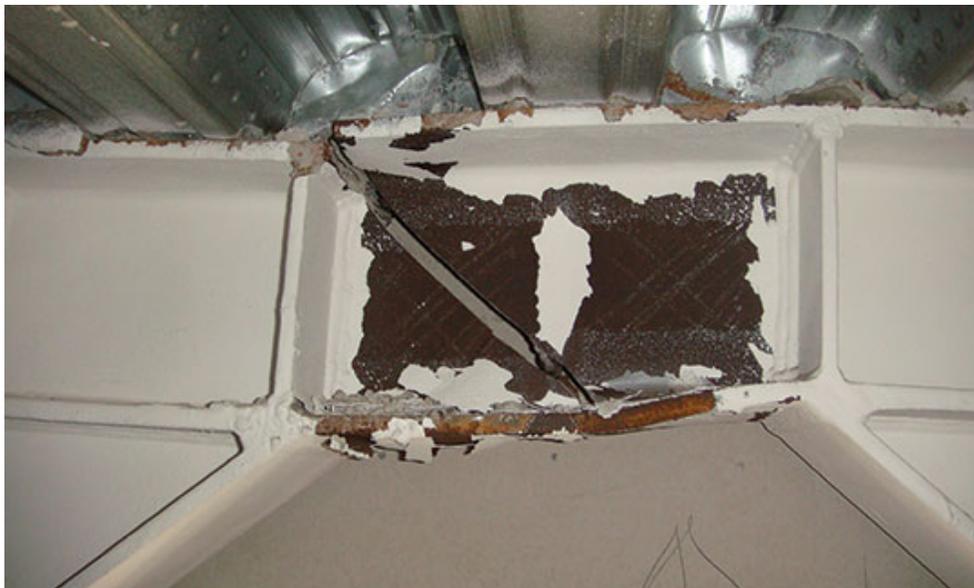
Figure 2: Fracture in an Eccentrically Braced Frame in the Pacific Tower.  
Courtesy of Sean Gardiner, CPG New Zealand Ltd.

The tower has completed structural repairs as of May 2013, having its steel bracing frame repaired and the hotel portion has reopened. This makes the time to repair slightly in excess of 2 years. Although a few faults were discovered in its bracing system, with only one active link showing failure, all braces had to be inspected before the building could be given permission for occupancy.

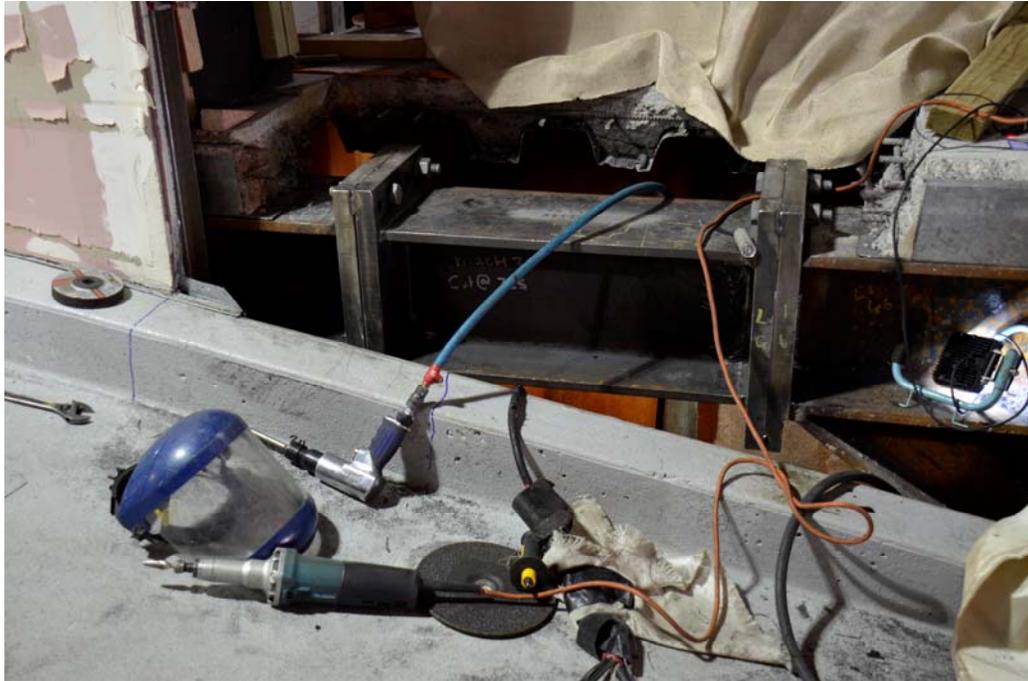
Figure 3: A link element in a braced frame in Pacific Tower.  
Note that the wall had to be torn away to provide access to the joint,  
and the access is still not ideal for labour.

The steel bracing system in the Pacific Tower is concealed and is therefore taking longer to remediate. Damage must be done to the building to expose the braces for inspection purposes. This adds to the cost and time for repair. However since the inspection requires the exposure of all of the vulnerable points of the frame, the system is being retrofitted with new links as part of this process. As the bracing system was not designed with exposure in mind, many of the sections that are in need of remediation and repair are located in very difficult to access locations. This also slows the repair process.

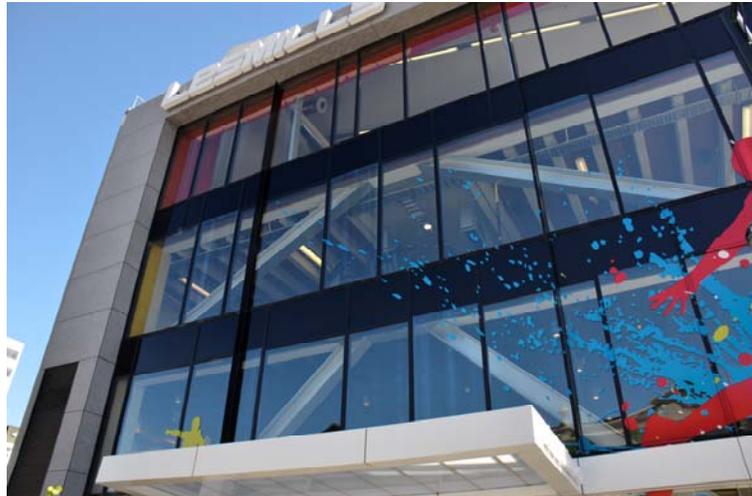
Figure 4: Exposed bracing at the Lesmills Fitness Centre in Christchurch.

Exposed bracing systems have already been successfully adopted by some Christchurch businesses. The Lesmills Fitness Centre makes a simple expression of the braced steel frame behind its façade. It is architecturally exposed to the interior as well as exterior through the glazed façade. To speculate on more widespread use of this type of framing, with the added benefit of the replaceable link system seems to make a lot of sense.

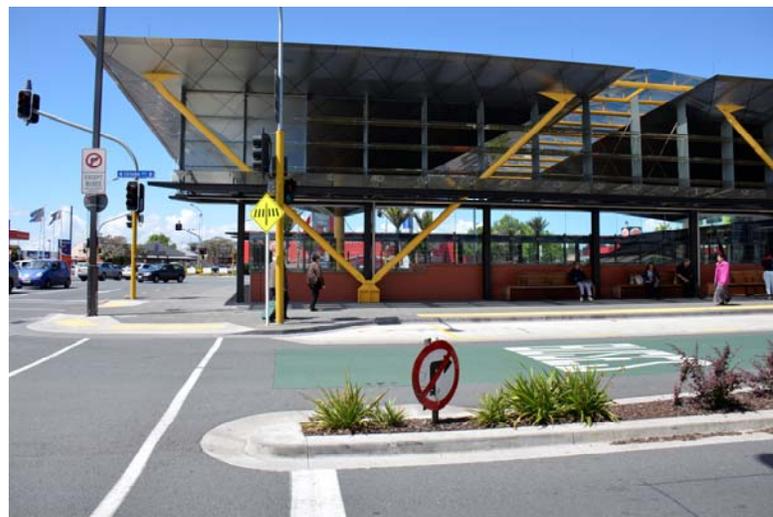
Figure 5: The New Lynn Transit Station in Auckland, New Zealand uses AESS effectively to create Award Winning architecture. The diagonal braces could easily provide the basis for a “seismic aesthetic” if modified for that purpose.

Exposed bracing systems are also already part of an aesthetic of Architecturally Exposed Structural Steel (AESS) systems that can very easily be adapted to include seismic functionality and a transparency of purpose in their design intent. Exposure of these steel bracing systems can effectively create a *new seismic vernacular* that could be applied equally well to new or retrofitted structures. It is not difficult to imagine simple modifications to current AESS bracing that would make it effective as a seismic system – or vice versa.

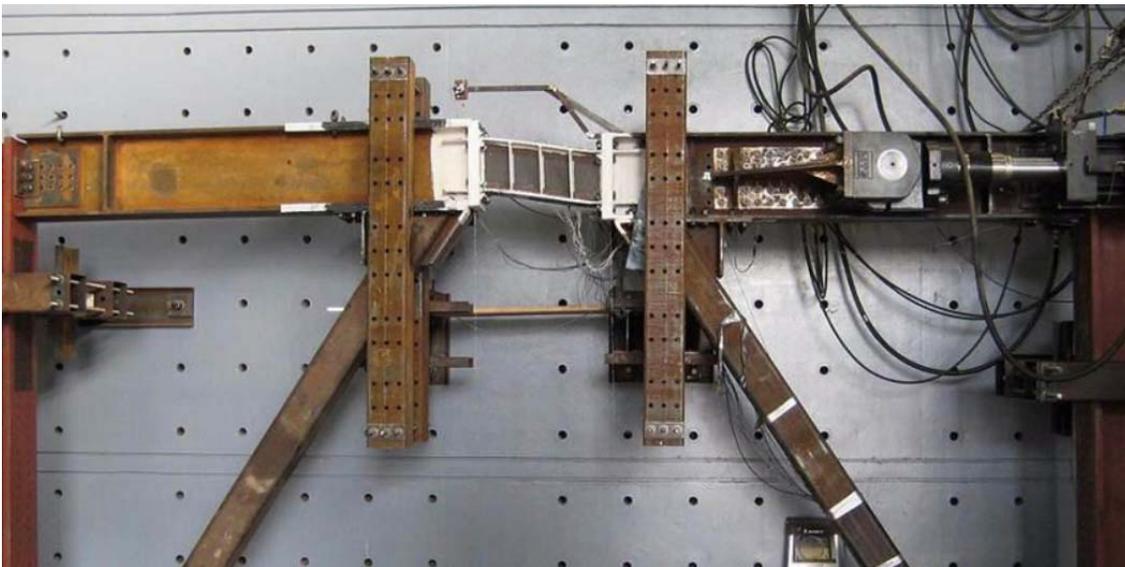
Figure 6: Test setup – frame at 1.7% drift, and total plastic link rotation of 0.113 radians.  
Photo courtesy of University of Toronto.

The simple version of the idea is to create well controlled weak spots in the Eccentrically Braced Frame (EBF) that will fail during a seismic event and absorb the energy of the quake in the process. In

failing the energy of the event is absorbed by the link in a sacrificial move, and the balance of the frame remains intact. If this link remains exposed, then inspection and replacement become quite straightforward. What is unique about Mansour's approach is the way that the link is bolted into the frame. Up to this point the link in EBF systems was integral to the spanning member. If the link failed, it would have to be cut out and a new section welded into place. By using a short wide flange section with plates welded to its ends that is bolted to the frame, the failed link need only be detached and a new link bolted into place (after realignment of the brace elements).

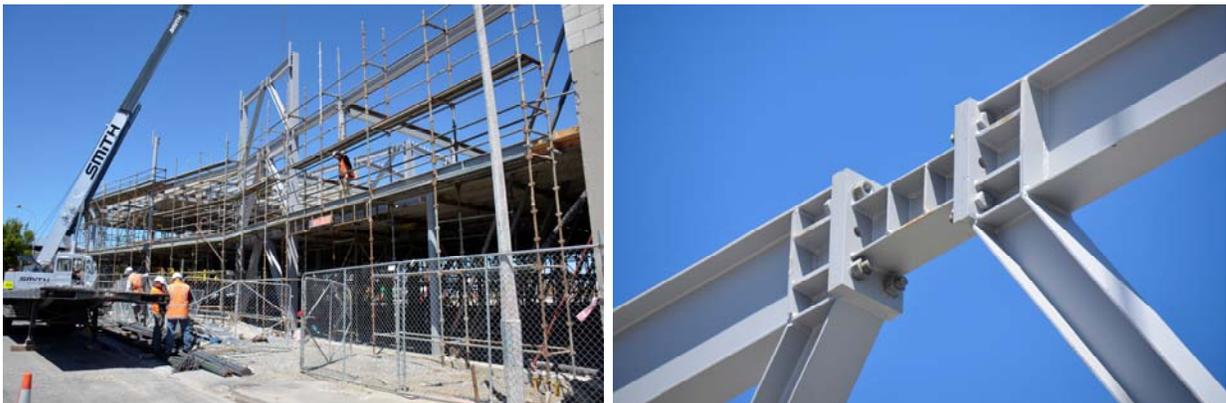
Figure 7: A braced frame in the *Three35 Project* that uses a "replaceable link" in post earthquake construction in Christchurch.

The system has been used in the recently constructed *Three35 Project* in Christchurch, designed by Jasmax Architects. SCNZ in conjunction with HERA and Associate professor Charles

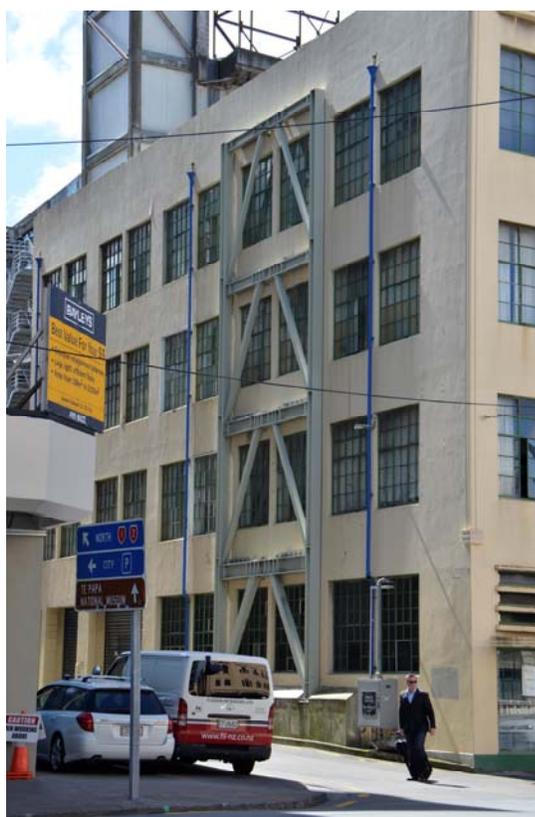
Figure 8: Existing seismic retrofit in Wellington, New Zealand.

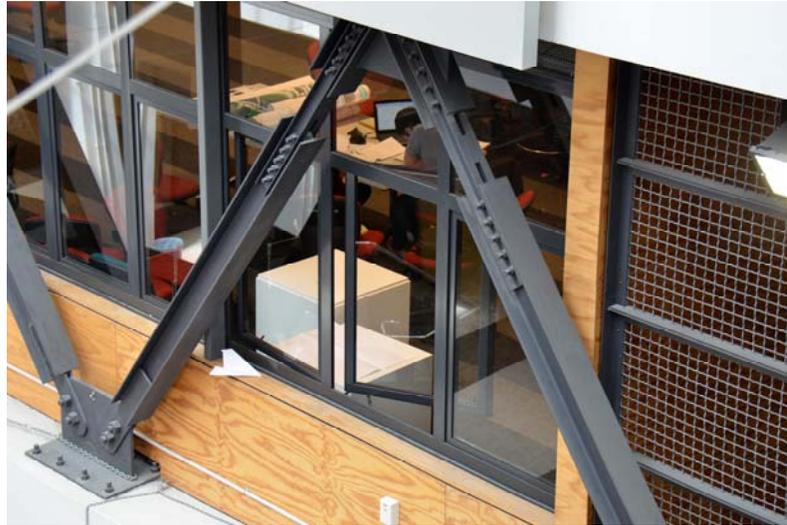
Figure 9: This retrofit bracing is located in the atrium of the School of Architecture in Wellington, New Zealand. These innovative braces are using fairly standard, tested, section types but creating a different sort of bolted link section. They have become a key aspect of the architectural aesthetic of the space.

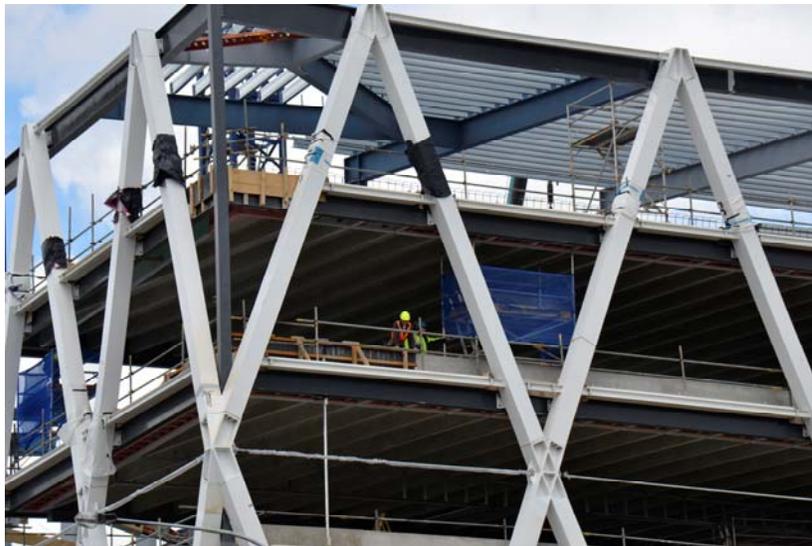
Figure 10: The Manukau Institute of Technology in Auckland, New Zealand designed by Warren and Mahoney Architects uses a perimeter diagrid on its exterior to purposefully express the structure. Note the absence of vertical columns. EBFs are used on the building interior to assist with seismic resistance. These are left exposed.

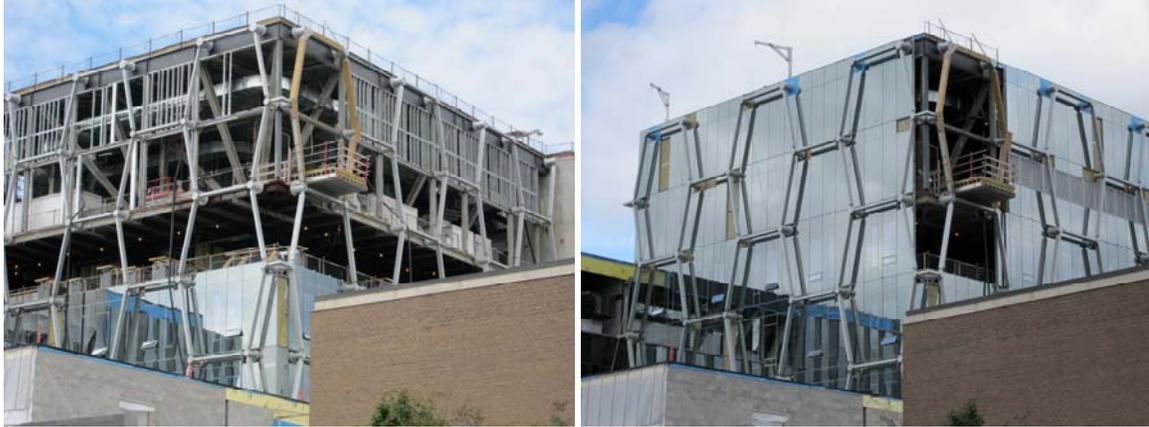
Figure 11: A system of exterior bracing is used on this laboratory building at the University of Waterloo in Canada, designed by KPMB Architects.

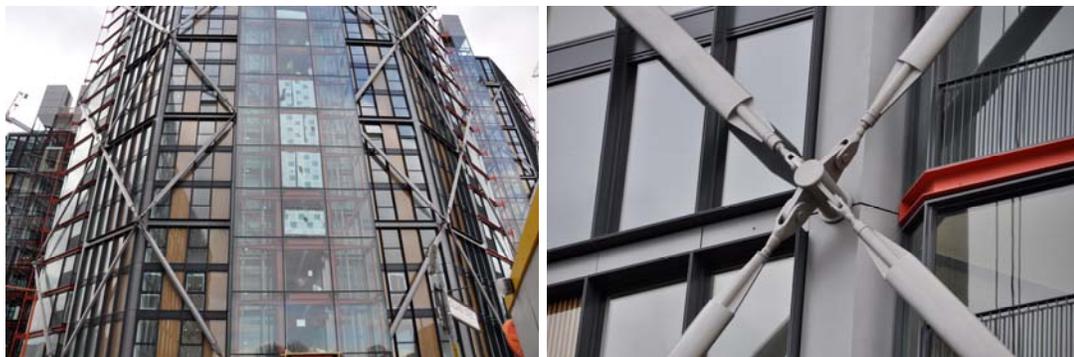
Figure 12: An external bracing system is used on the NEO Bankside housing project in London, England by Rogers Stirk Harbour and Partners. Although not designed for seismic resistance, the bracing system is proudly exposed and a critical part of the aesthetic of the building.
