# ACSA Annual Meeting, Technology Conference Montreal, June 1999:

## **MEASURING A BUILDING'S VITAL SIGNS: *Cold Climate Case Studies:* The YMCA Environmental Learning Center, Paradise Lake, Ontario**

### **YMCA Environmental Camp, Paradise Lake, Ontario. Charles Simon, Architect**

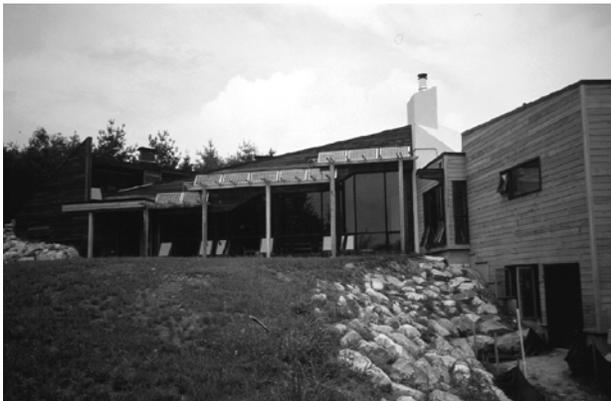
*View of Burrows Residence showing south facing exposure*

This camp building was designed to be entirely energy and systems independent. It has sleeping accommodation to house 40 campers. The building is organized with a main gathering room on the south glazed side of the building adjacent to a large masonry heater. Behind this space, on the north side of the building, which is earth-bermed and lit by clerestory windows, are 8 sleeping bedrooms. The building is heated via passive solar in combination with a large wood burning custom designed masonry heater. There are no other supplementary sources of heat. Students investigated heating patterns during the winter for both sunny and cloudy days; the effectiveness of the masonry heater; and daylighting for both the large common room and clerestory lit sleeping quarters. The primary structural, floor and finish material used in the Burrows is reclaimed wood. This is an excellent material choice when sustainability is a central concern, but fails to provide thermal mass for passive solar storage. Key questions that the students studied included: the distribution of thermal mass, the ability of the masonry heater to warm the building, daylighting levels, and the effectiveness of earth berming in reducing energy requirements. In investigating heating levels, the concern was to see if there was a level of uniformity in various parts of the building and, if not, if the deviation was acceptable in terms of occupant comfort.

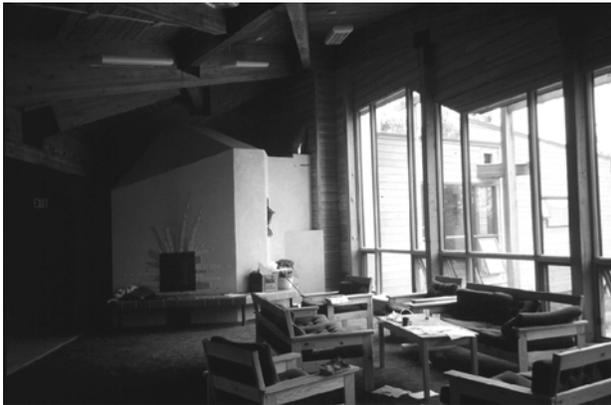
*Interior view of common room and masonry heater*

The week in which the data was collected had varying weather conditions, which impacted the readings and provided an interesting range of output. The outdoor temperature varied from a high of 8C to a low of -20C, averaging -7C. There were days of sun as well as cloud. The average indoor temperature varied between 16C and 24C. Through comparison of the temperature and lighting data the students were able to find that the temperature profile of the indoor environment was more closely connected to the impact of solar radiation on sunny days than with the outdoor temperature. The indoor temperature was at its lowest on cloudy days even though this coincided with the warmest outdoor temperatures of the week. There was a strong correlation between the temperature at the main room window and the temperature at the back wall of the main room. This suggested that the building effectively transfers the heat from the heat from the solar gain at the glazing to the ambient air temperature near the back wall where there was no direct sunlight. The window temperature was also never below the temperature at the wall in the center of the building. This suggests that the windows are quite efficient and that the thermal massing of the thick internal masonry wall is fairly effective at releasing heat throughout the colder hours. This would also support the use of this masonry wall for its thermal capacity and the use of carpet covered reclaimed wood flooring for the main space -- selected for reasons of residential foot comfort.

It would appear from the collected data that the heater was not fired in the evening of March 10 and in the evening and morning of March 11. However, during this time the temperature of the main room stayed relatively steady. This steady temperature is likely due to a combination of large solar gain during these days and the effectiveness of the thermal mass of the heater. As well, during March 14 and 15 the temperature at the surface of the furnace dropped even though it was still being fired. With a few hours lag-time, this time of lower heater temperatures also correlated with the period of low solar gain. This would suggest that the masonry may also be acting as an effective thermal mass which is strongly effected by the amount of solar radiation. According to employees at the Environmental Center if the wood furnace isn't fired at all, it takes several days for the building to get down to 3C to 4C where it

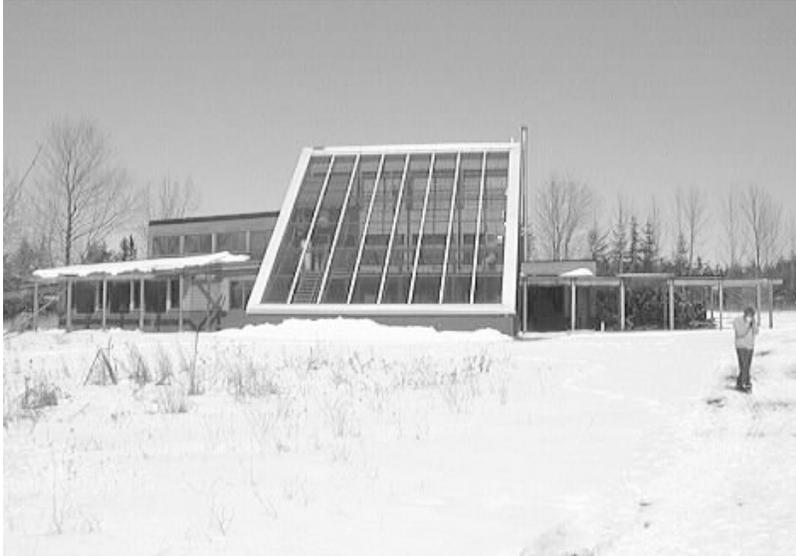
*South elevation of solarium building*

The building's program is centered around the south facing greenhouse, which acts as both a source of heat for the rest of the building and a greenhouse within which food producing plants are grown. The roof of the greenhouse slopes from south to north, starting at 2 feet off the ground and rising two stories to form a mezzanine at the north end of the space. The room contains a ventilation system which automatically opens and closes to allow the room to cool naturally by the physics of air flow (heat rises and exits through the vents at the top north side of the greenhouse, thereby sucking cooler fresh air through the bottom south vents).
