WHEN FAÇADES KILL

A problem of extreme flammability

Terri Meyer Boake / University of Waterloo

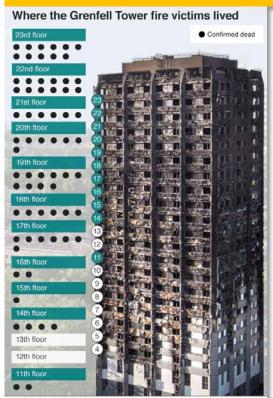
Grenfell Tower, London | June 14, 2017

- 27 storey tower
- Residential, operable windows (summer night, open), no balconies
- 71 deaths
- Fire started on the inside of the building from a malfunctioning fridge that burnt through to the cavity
- Spread from 4th floor upwards in 15 minutes
- Re-clad in non fire rated aluminum panels with low density polyethylene core using a rain screen with an additional 150mm polyisocyanurate insulation and a 50mm continuous cavity
- No fire alarms in building
- Single stairwell

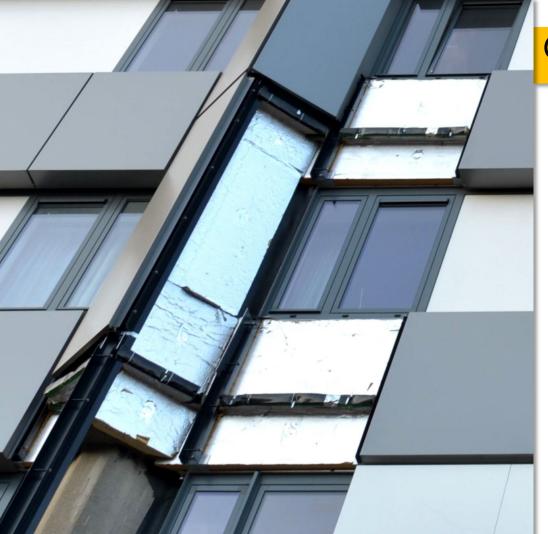
- In a statement on its website, Omnis Exteriors said panels such as Reynobond PE should only be used with "a non-combustible insulation material such as mineral fibre" if they are to be installed on high-rise buildings.
- The fire resistant panel was dropped due to cost reasons
- Massive failures in communication
- Massive investigation underway, changes coming to the British codes.

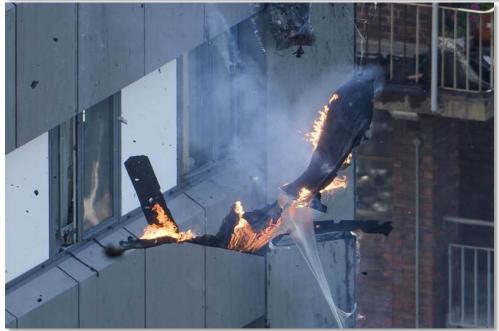
Low Density Polyethylene Insulation (LDPE):

- The softening of the aluminum combined with the melting of the LDPE insulation led to the panels falling off of the building.
- Fire resistance tests for the panels assume that the panels are sealed so that the edge condition does not expose the interior LDPE core

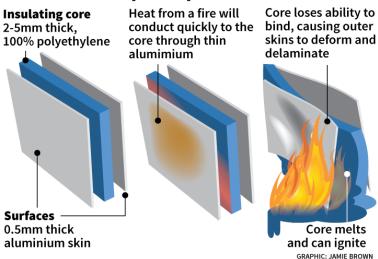
AUE Façade Fires:

Aluminium composite panel Flammable core

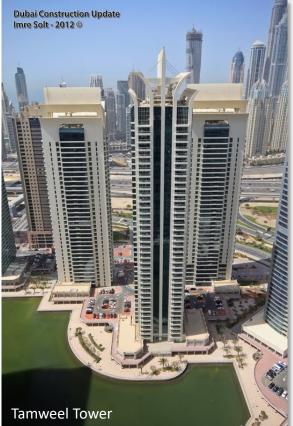
- In the Tamweel fire there is mention of a forthcoming increase in the balcony railing height as a fire prevention
- In theory the balcony should act as a fire break ledge, <u>unless itself</u> clad in flammable materials
- Balconies would also need to be continuous to act as a ledge break
